Source: Leece-Neville Heavy Duty Systems Division - Arcade, NY USA  
 Date: July 7, 2017  
 Bulletin No: TSB-1026  
 Models: 8SC2023Z  
 Subject: Wiring Diagram

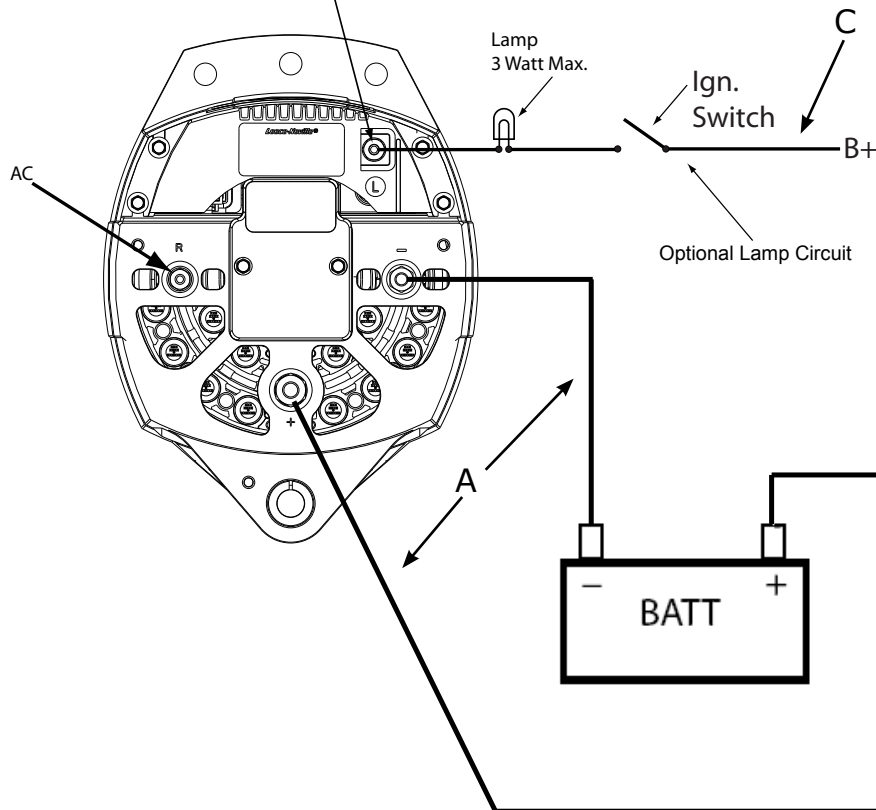
**Lamp Circuit Notice!**

Circuit is optional and is not needed for normal alternator operation.

Circuit is not a D+ (Diode Trio) terminal.  
 If a fault occurs in the alternator or not rotating, a path to ground is established.  
 If alternator is operating properly the path to ground is removed.  
 This circuit does not provide a voltage source while the alternator is operating.

Regulator will be damaged if connected directly to battery.
